DEPARTMENT OF TRANSPORTATION**DIVISION OF ENGINEERING SERVICES**

Contract #: 04-0120F4Cty: SF/ALA Rte: 80 PM: 13.2/13.9File #: 1.28**WELDING INSPECTION REPORT****Resident Engineer:** Casey, William**Address:** 333 Burma Road**City:** Oakland, CA 94607**Report No:** WIR-027220**Date Inspected:** 16-Feb-2012**Project Name:** SAS Superstructure**OSM Arrival Time:** 700**Prime Contractor:** American Bridge/Fluor Enterprises, a JV**OSM Departure Time:** 1730**Contractor:** American Bridge/Fluor Enterprises, a JV**Location:** Job Site**CWI Name:** Salvador Merino**CWI Present:** Yes No**Inspected CWI report:** Yes No N/A**Rod Oven in Use:** Yes No N/A**Electrode to specification:** Yes No N/A**Weld Procedures Followed:** Yes No N/A**Qualified Welders:** Yes No N/A**Verified Joint Fit-up:** Yes No N/A**Approved Drawings:** Yes No N/A**Approved WPS:** Yes No N/A**Delayed / Cancelled:** Yes No N/A**Bridge No:** 34-0006**Component:** OBG**Summary of Items Observed:**

WELDING INSPECTION REPORT

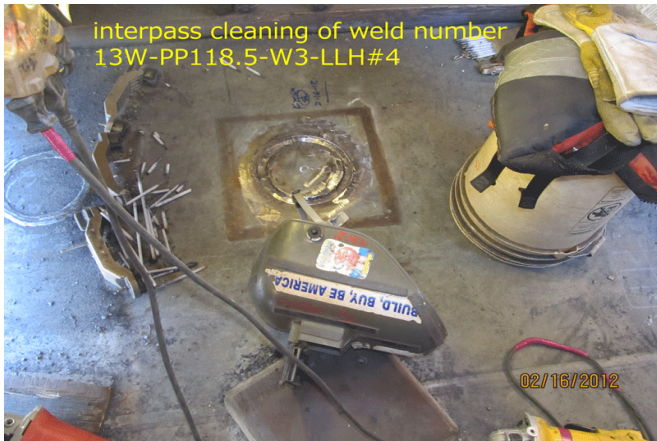
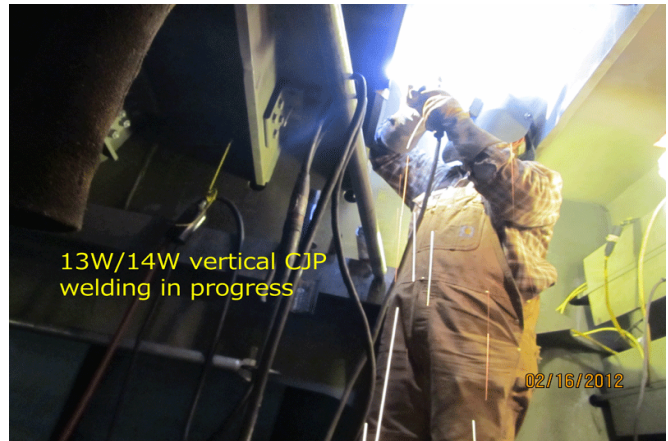
This QA observed, at random intervals, ABF/JV qualified welder Jason Collins #8128 performing Shielded Metal Arc Welding (SMAW) with 1/8" diameter E7018H4R electrode and implementing Caltrans approved Welding Procedure Specification (WPS) ABF-WPS-D15-3010-1. This was a Complete Joint Penetration (CJP) weld on a 20mm plate insert at the "A" deck to close the manway access hole. This work was located at 9W/10W at counterweight side of deck between counterweight and barrier rail weld is identified as 9W-PP84-W5. During welding, ABF Quality Control (QC) Salvador Merino was noted monitoring the welding parameters. Welding parameters were recorded.

This QA observed, at random intervals, ABF/JV qualified welder Mike Jimenez #4671 performing Shielded Metal Arc Welding (SMAW) with 1/8" diameter E7018H4R electrode and implementing Caltrans approved Welding Procedure Specification (WPS) ABF-WPS-D15-1050A-CU. This was a Complete Joint Penetration (CJP) weld on a 20mm plate insert at the "A" deck to close the lifting lug deck penetration holes. This work was located at 13W PP119.5 W3 3 was performed in the flat position from the topside of the "A" deck plate. During welding, ABF Quality Control (QC) Salvador Merino was noted monitoring the welding parameters. Welding parameters were recorded. Also verified that CU backup strip was secured from top and under deck.

This QA observed, at random intervals, ABF/JV qualified welder Richard Garcia #5892 performing Flux Cored Arc Welding (FCAW) with 1.6mm diameter E71T-1M electrode and implementing Caltrans approved Welding Procedure Specification (WPS) ABF-WPS-D15-1012-3. This was a Complete Joint Penetration (CJP) weld connecting vertical stiffener plates to stiffener plate. This work was located at West line connection joint 13W to 14W LS 5.
